# Manhole Inspection Summary

Manhole # S15A1\_020MH

Insp Date: **6/20/08 2:03 PM**

**Location** Address: **2801 georgetown rd**

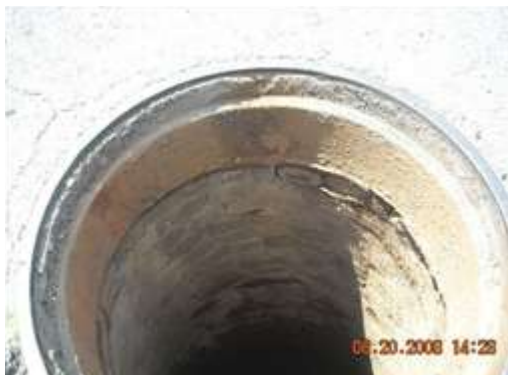
Misc

Subject To Ponding: **Sheeting**

inflow evidence from sheeting

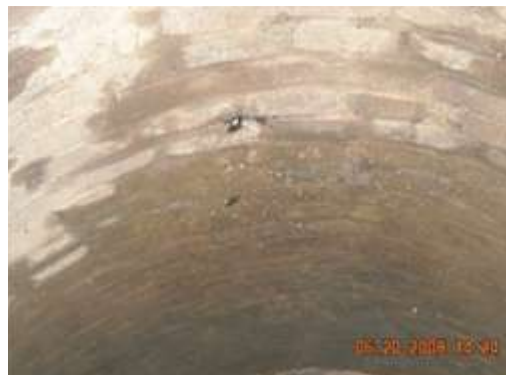
Defect 4

Infiltration: ☐ None ☐ Joint ☐ Cracks ☐ Mortar ☐ Roots ☒ **Wall**

barrel flow wall

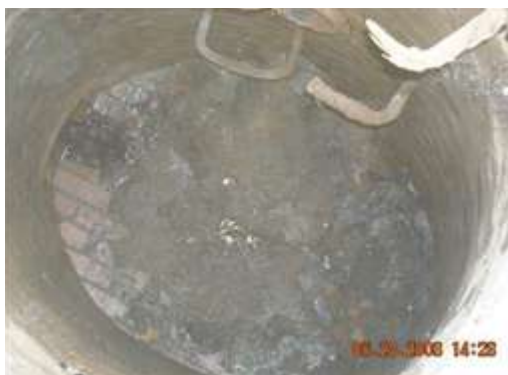
Defect 2

Condition: ☐ Sound ☐ Cracked ☐ Root Intrusion ☐ Deteriorated ☐ Leaks ☒ **Debris**

debris in terminal channel

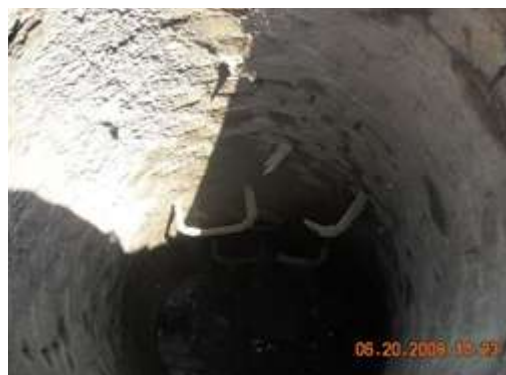
Defect 1

Count: **2** Missing: **3** ☒ **Corroded**

corroded & missing steps

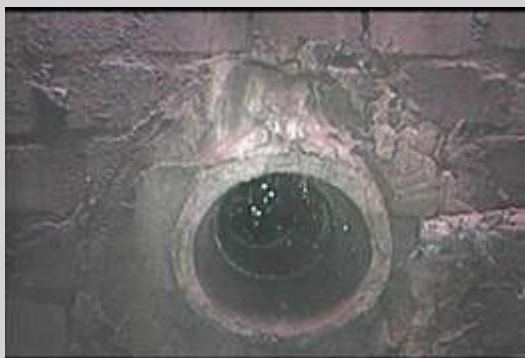
3 O'Clock Inflow

Pipe Height: **6** (in.) Rod and Bar (Angled)  
Pipe Material: **Clay** ☐ Pipe Lined  
Invert Depth: **5.99** (ft.) Flow Characteristics: **None**  
Deposits: ☒ None ☐ Mud ☐ Sludge ☐ Debris ☐ Grease  
Silt Depth: **0** (in.) Deposits Extent:  
Infiltration: **None** Pipe Seal Cond: **Broken**
